Steering Column Services

Jeep Ignition Switch & Lock Cylinder Replacement Instructions

This design was used on many Chrysler, Dodge and Jeep vehicles from the mid 1980's through 1995. The vehicle used in this example is a 1990 Chrysler LeBaron.

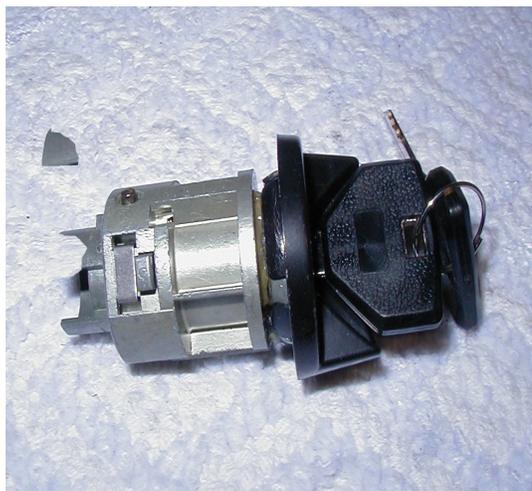
The lock cylinders often break, stopping the key from turning enough to start the car. If this is the case, if the vehicle was stolen, or the switch is damaged (as in the pictures) these instructions will show you how to repair / replace these parts.

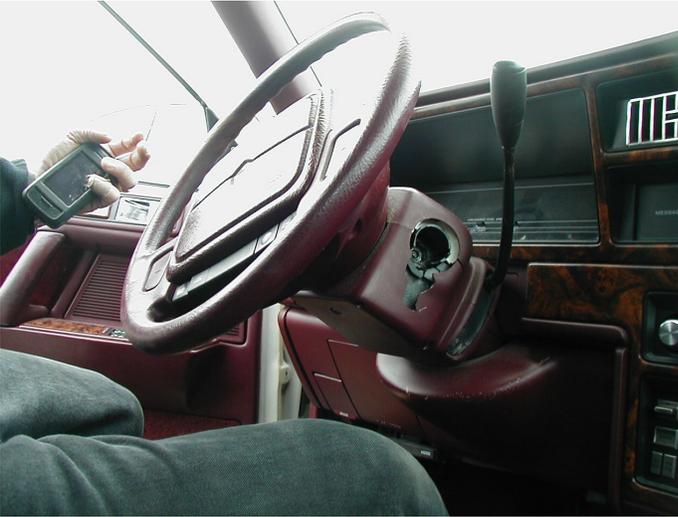
1) Raise the column to the uppermost tilt position

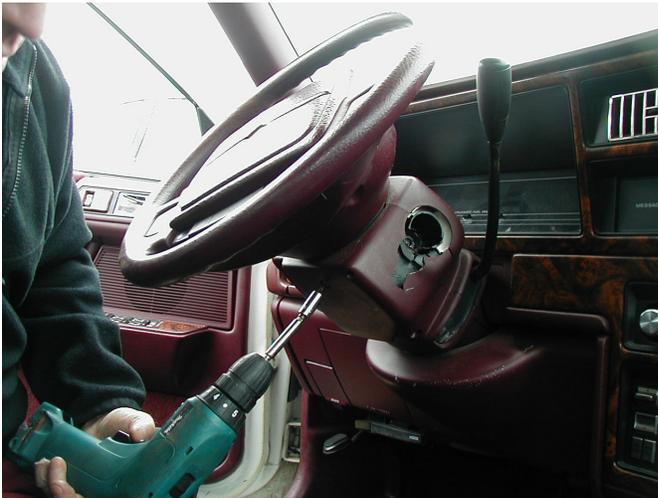
2) Remove the lower steering column cover. This design uses 2 screws to hold the covers together and a 3rd holding the lower cover to the column.

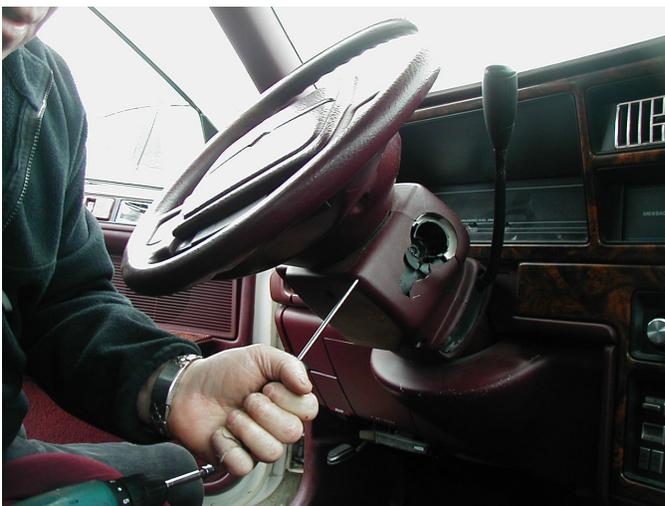
3) All of these screws should be 20 torx. The covers snap together closer to the dash and can be pulled apart after all the screws are removed.

Close-up view of release hole on the switch. This view also illustrates the proper placement of the locking bracket often included in replacement locks. The new black torx screw with a shoulder goes in this hole and secures the new lock. (Do not overtighten)

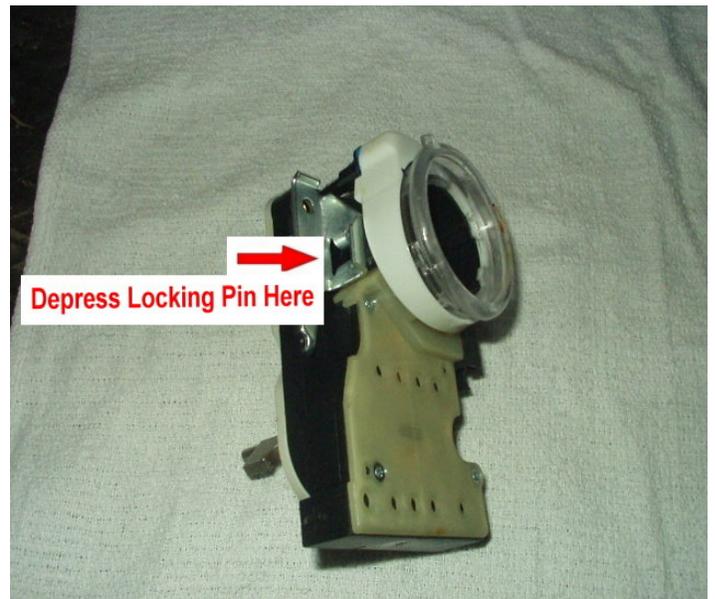
Once depressed, the lock cylinder will slide out of the switch.

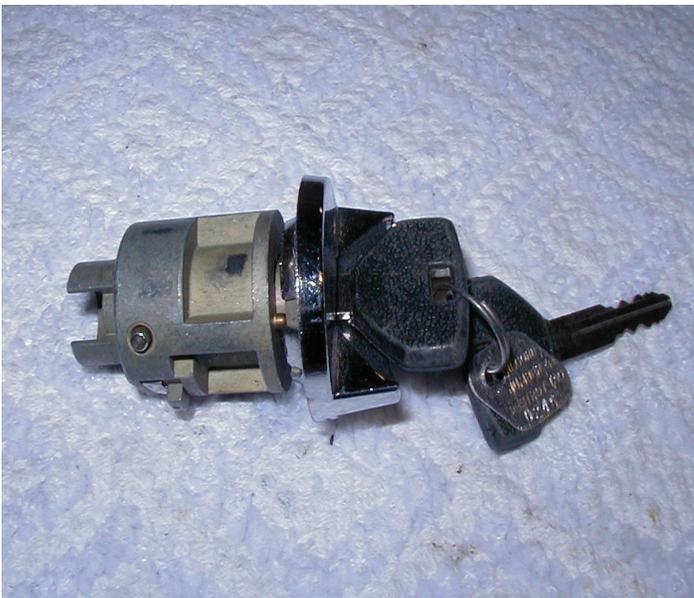
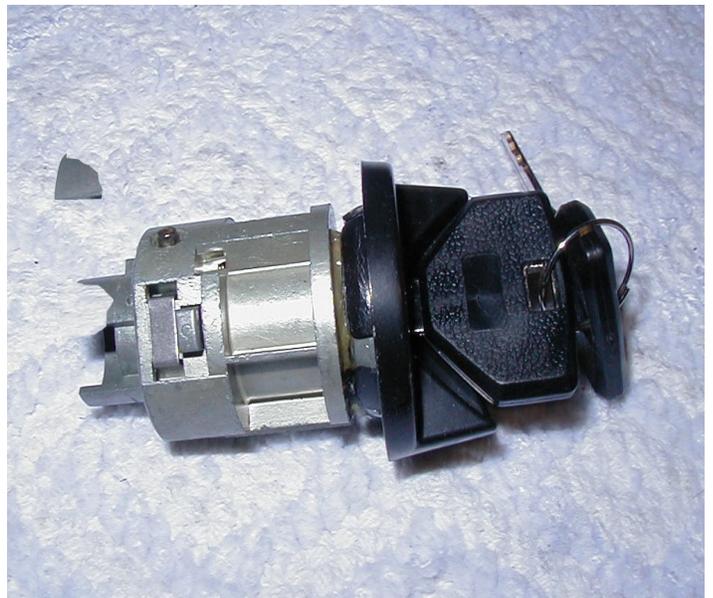
If the lock cylinder is broken (as illustrated) make sure you locate and remove the broken piece from inside the switch to avoid an electrical short.

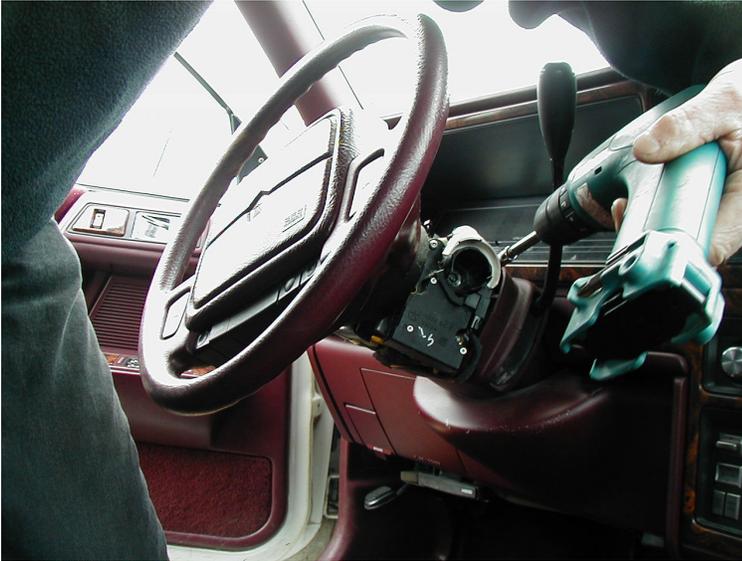
Remove the ignition switch assembly with (or without) the lock cylinder. These 3 bolts are also 20 torx, but are tamperproof, requiring a different socket.

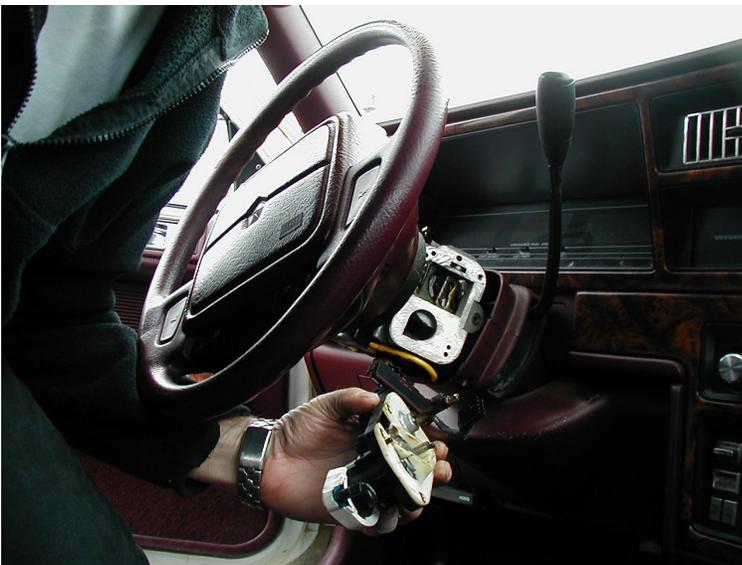
Lower the switch assembly to remove the wire connectors.

When installing the new switch, make sure the inside mechanism locks and releases the shift interlock bracket properly by rotating the key to all positions while applying pressure to seat the switch.
